Singer Le Mans: Story of rear axle repair

Hans-Christoph Mertins, 22.8.2024, hc.mertins@gmx.de

My car, Singer Le Mans, 1934, 2-Seater, 1 litre, Car No 62743 had problems with the differential. It produced noise when the gears are changed, i.e. when the clutch is released and the transmission is under load. The right wheel also wobbles. The backlash of the drive shaft is large, i.e. it rotates by hand 90 degree before wheels start to rotate. In the following the repair process is described. However, a very detailed, general description of rear axle repair is found at mothy.co.uk by Roly Alcock who gave advice to identify and solve problems.

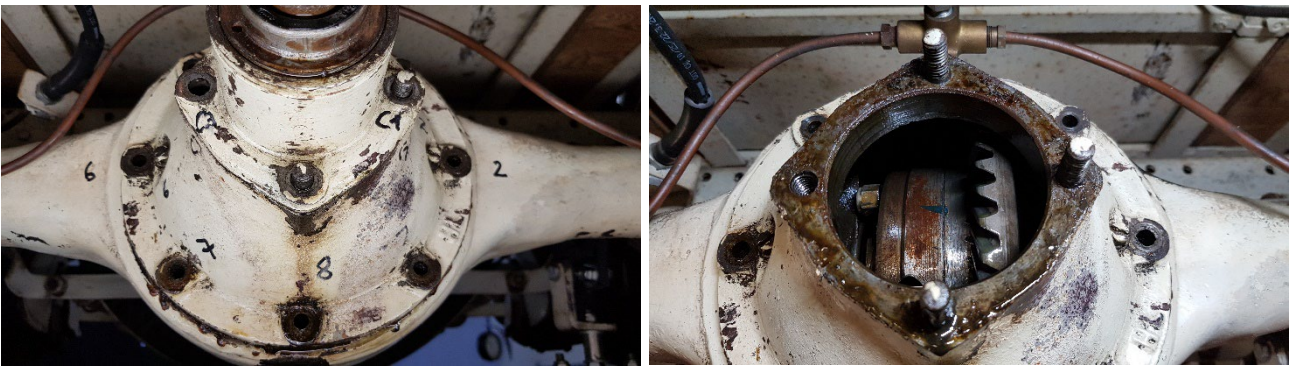
Pinion unit

Teeth 7, printed on the body: 97 (unclear) and below 460;

All teeth are very rough and partially damaged with 1-3 mm roughness;

No wobble when rotated, easy to rotate but slight scratch after half revolution;

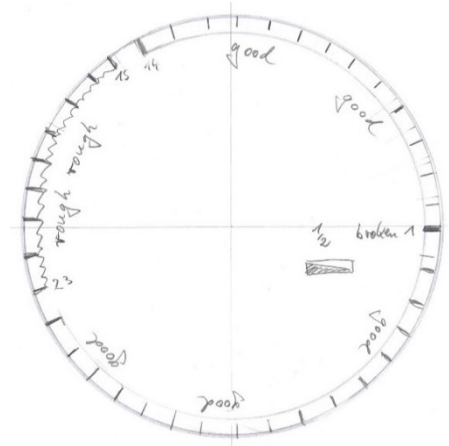
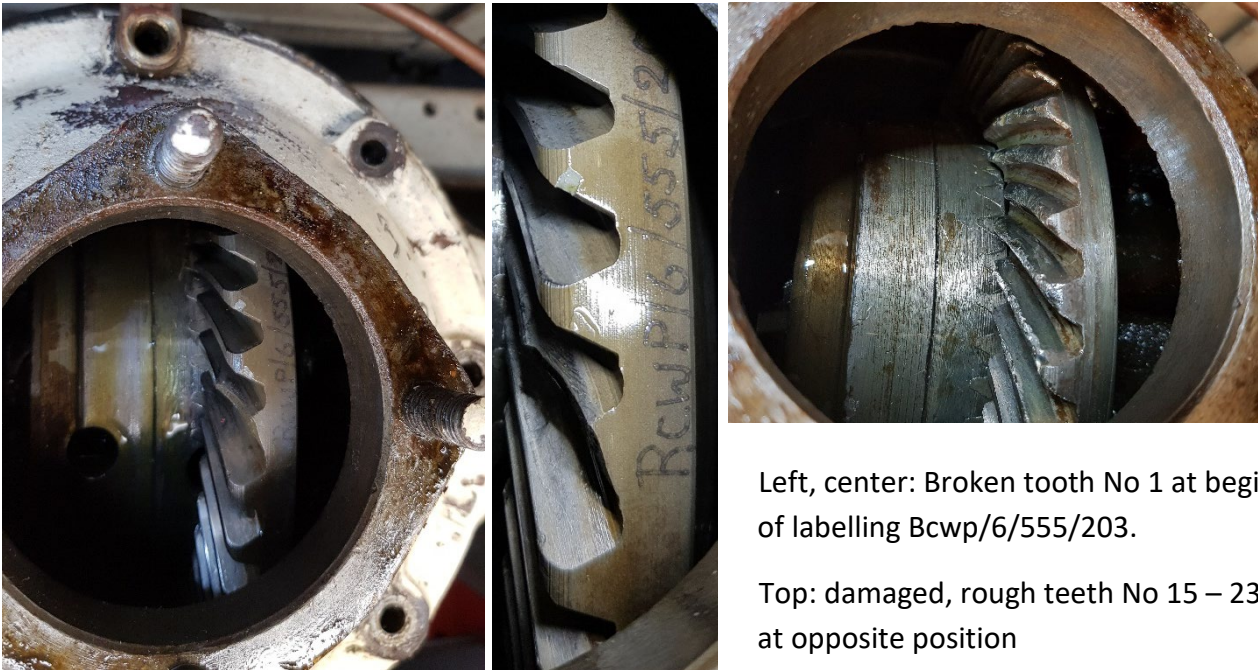
Crown Wheel

The crown wheel teeth are damaged partially;

No 1: broken, half tooth along length direction is missing (sketch);

No 15 to 23 are damaged on top, very rough 1-3 mm missing;

Broken tooth No 1 and damaged region are on opposite positions of the crown wheel =>

Left, center: Broken tooth No 1 at begin of labelling Bcwp/6/555/203.

Top: damaged, rough teeth No 15 – 23 at opposite position

Backlash: when rotating the CW it takes about 3-4 mm until the half shaft (wheel at the side of the CW) starts to rotate. This is about 2 degree backlash and does not explain the large backlash of 90 degree when rotating the mounted drive shaft before the wheels start to rotate

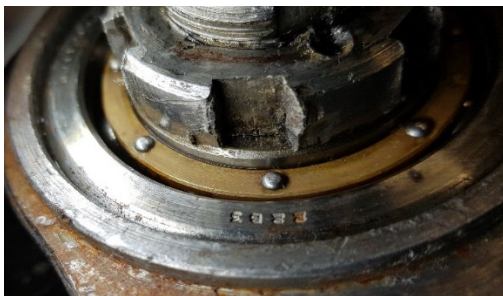
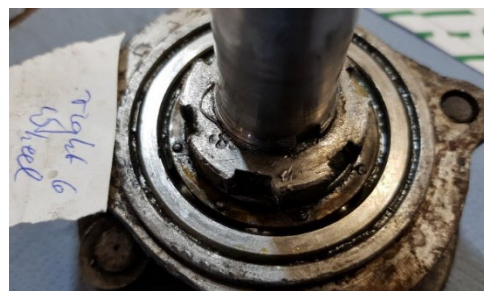
- Right: bearing defect, moveable in axle direction +/- 1-2 mm
- Left: defect radial: shaft at Wheel side D = 28.3 and bearing D = 28.55
Shaft too thin
- Half shaft left, right side identical with
Diameter = 25.25 – 25.35 mm (figure above at 45 mm position and 60 mm) in Diff
Total Length 494 mm, Notches are ok
- Bearings
Outer ring: Diameter = 71.45 mm MJ1 I/8-
Brass ring: J 30 – A
Inner ring: Diameter = 28.62 R&M 31/SM 19AST
Thickness 20.6 mm
- Sealing
Dout = 60.3-60.5, Din = 41.2, w = 7.0 – 8.5 mm
Simmering Doppellippe Din = 41.2, Dout = 60.3, w=9.5,

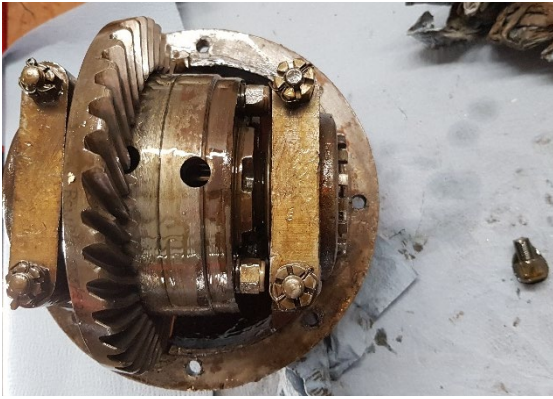
Problem: one of three screws fixing the Crown Wheel was broken (left figure) and the two other were not tight so that the CW was not pressed perfectly to the pinion which must be the reason for scratched teeth on the CW.

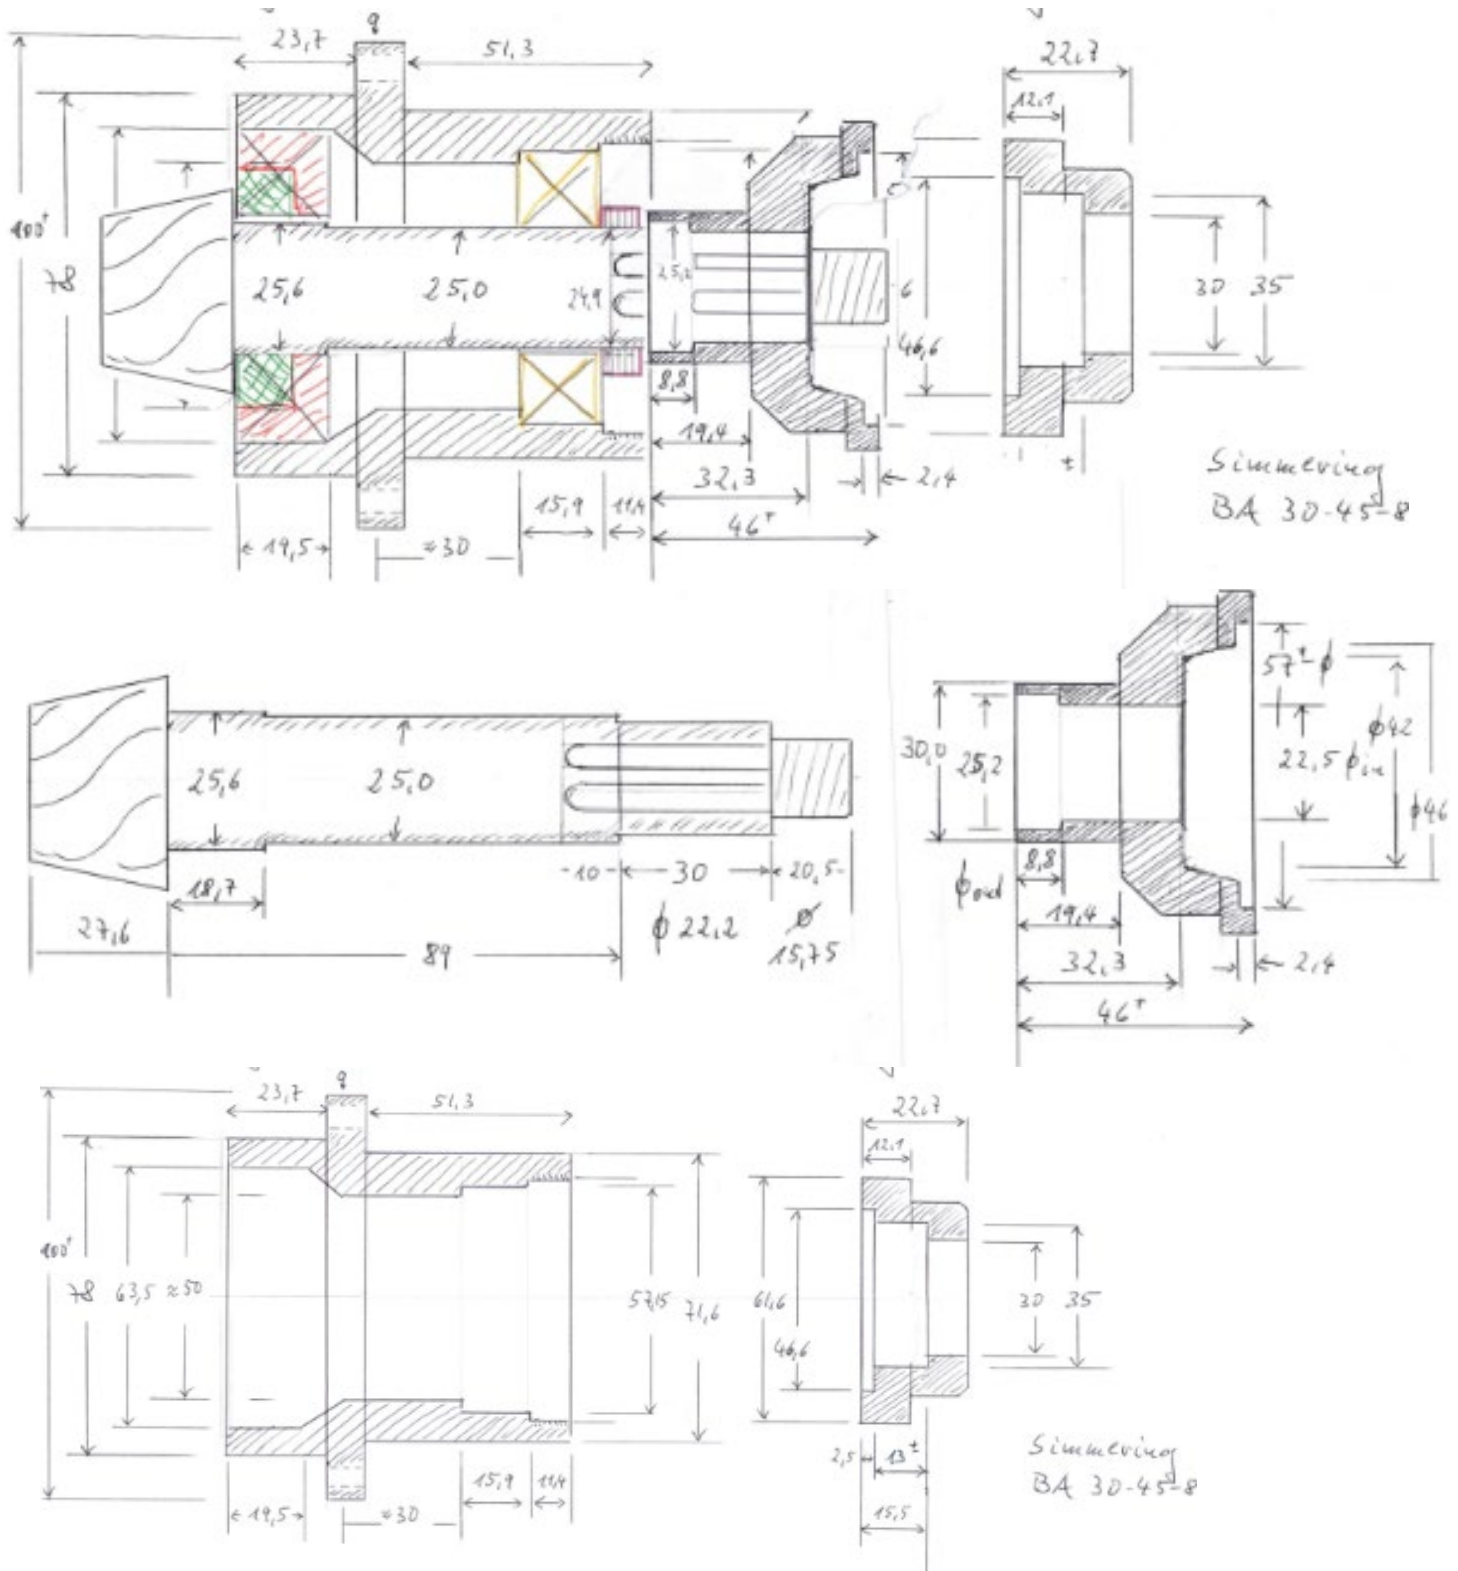
Repair Pinion

Now we are coming to the most challenging part – my pinion housing which differs from the typical Singer LM. So I show drawings with values for those who might face same problems like me (hopefully not). However, the new pinion shaft I ordered at Hardwick Spares exactly fits to the housing with respect to the length so that CW and Pinion match perfectly at the end. However, the shaft diameter varies slightly and must be adapted using the central ball bearing with appropriate diameter.

The Pinion housing (Fig. above bottom) has to be modified to accept the right ball bearing with slightly large diameter compared to the old ball bearing using a lathe.

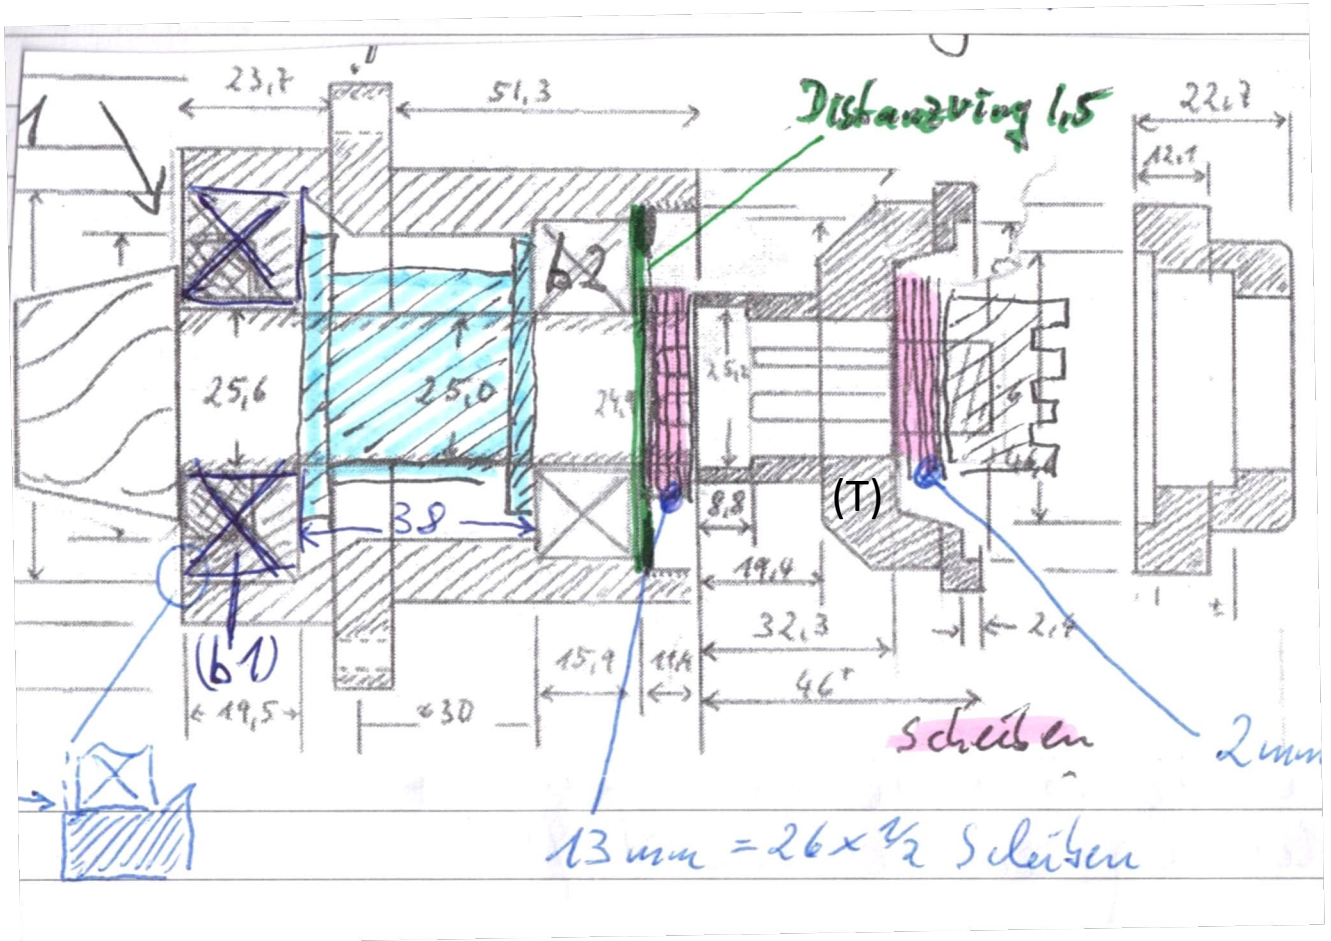
I calculated the forces acting on the pinion shaft. If starting to drive the car with acceleration of 0 – 100 km/h in 20 seconds with gear ratio 39/7 I find 1.9 kN which is a factor of 10 lower than provided by this ball bearing (sufficient dynamic load rating needed as back up additionally to the spacer).

Most important is the implementation of a spacer tube between the two ball bearing (not shown in the above figures but in the fig. below in blue). The job is to reduce the huge forces between bearing (b1) and (b2) (Fig. below) when driving and to avoid damage of the bearings.

The distance tube (spacer) length is 38.0, diameter $D_{in} = 25.0$, $D_{out} = 38.0$ (Fig. below, blue)

Bearing (b1) RMS8 from SKF $D_{out} = 63.5$, $D_{in} = 24.4$, $t = 19.05$
 Basic dynamic load rating 22.5 kN
 Deep Groove Ball bearing!

Bearing (b2) NTC 62/28/25 C3 $D_{out} = 57.87$, $D_{in} = 24.994$, $T = 16.0$
 Basic dynamic load 19.8 kN

We need distance washers (Fig. above, pink) to fix the pinion shaft in the housing. Additionally a special washer (above figure, green) was produced via Laser cutting. The job is to produce contact between the pinion housing and pinion shaft via part (T) fixed via the castellated nut. This green washer has to be produced because we had to work with a larger ball bearing (b2).

In the centre 13 mm washer distance and on the right, close to the castellated nut, 2mm are used. A precise washer thickness avoids a longitudinal backlash of the pinion shaft and maintains the distance between pinion head and crown wheel when driving (see below).

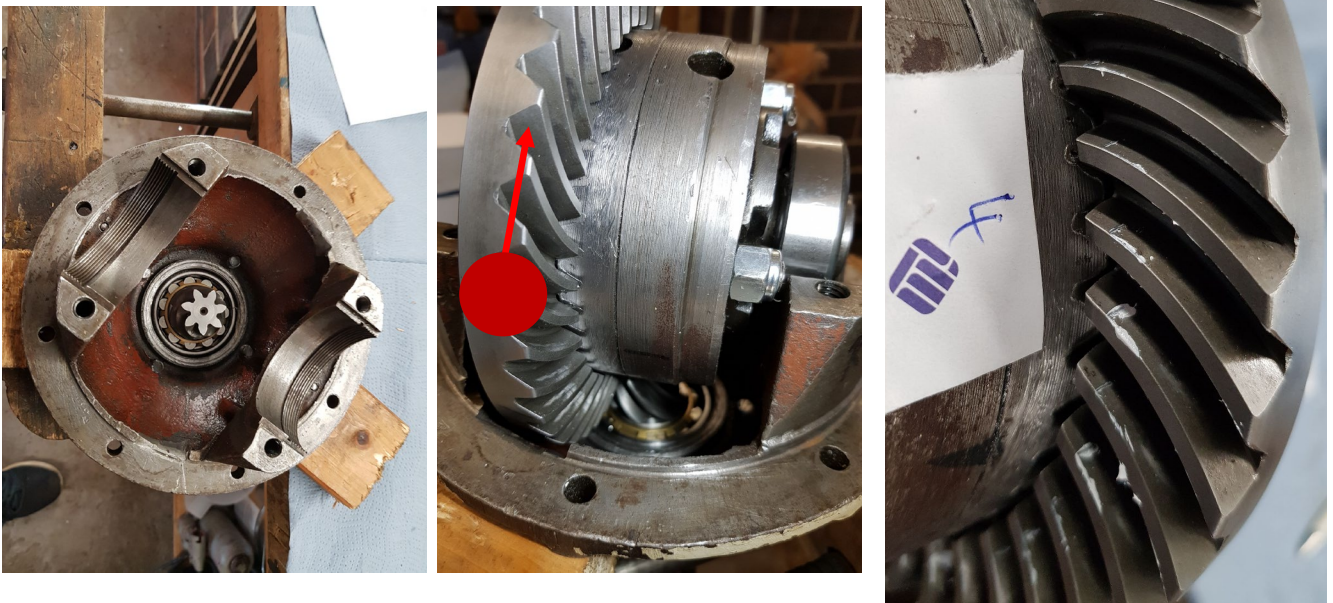
Alignment Crown Wheel – Pinion

To check the matching between teeth of pinion and teeth of crown wheel I tried with *Mechanics blue* (I used white) (Fig. above, right, white spots) but it is not helpful because the thickness of paint influences the contact more than the alignment of CW and pinion. Fortunately the metallic surfaces of both, pinion and CW teeth were completely new so that the traces of “first” metal contact could directly be seen (grey in Fig right). The matching was perfect according the pattern found in the literature (not shown here).

The pinion housing is mounted to the differential housing first. The pinion head extends into the diff-housing (Fig below, left). Then the Crown wheel is placed (Fig. below, right) so that both wheels fit. Then the housing (seat) is mounted (Fig. page 12, 13).

The alignment of backlash between Pinion and Crown Wheel is done as follows: hold the pinion shaft tight and avoid its rotation. Install a dial gauge (see p 13 but rotate by 90 degree as sketched in the Fig. above, red arrow) at the outer diameter of the crown wheel. It must measure the travel distance of a CW tooth when rotating the CW until it is stopped by the pinion. This backlash should be between 100 μm and 150 μm as I learned from Roly Alcock. The backlash is tuned by moving the CW along its rotation axis, i.e. in the Fig. above horizontally. Therefore the annular adjusting rings (not shown) have to be aligned and if necessary washers have to be implemented. I set the backlash to 150 μm and with this value the differential was working without noise at least when the car was running.

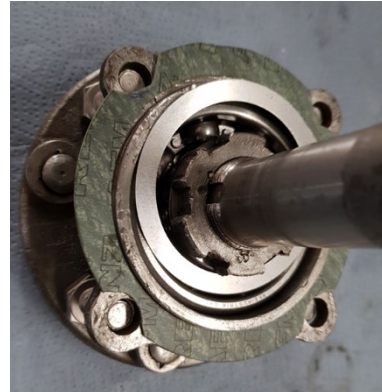
Repair Rear Axle: Wheel bearing

The old half shaft was too thin in diameter by 0.25 mm so that the bearing was not fix on the half shaft and leads to the wobble of the wheel. We had to increase the half shaft diameter at the bearing position. Therefor we decided to wrap two layers of micrometer foil (0.2 mm thick, stainless steel) which was laser welded on the half shaft. Laser welding set about 200 welding points so that the half shaft diameter increased. Then the needed smaller diameter to fit the ball bearing was produced on a lathe. Laser welding avoids thermal stress and bending of the half shaft!

- Ball bearing MJ1 – 1/8, from NKE
Diameter Din = 28.55, Dout = 71.4
- Sealing Simmering, double lip,
Din = 41.27, Dout = 60.32, thick = 7.93
