Singer Le Mans: Story of rear axle repair

Hans-Christoph Mertins, 22.8.2024, hc.mertins@gmx.de

My car, Singer Le Mans, 1934, 2-Seater, 1 litre, Car No 62743 had problems with the differential. It produced noise when the gears are changed, i.e. when the clutch is released and the transmission is under load. The right wheel also wobbles. The backlash of the drive shaft is large, i.e. it rotates by hand 90 degree before wheels start to rotate. In the following the repair process is described. However, a very detailed, general description of rear axle repair is found at mothy.co.uk by Roly Alcock who gave advice to identify and solve problems.

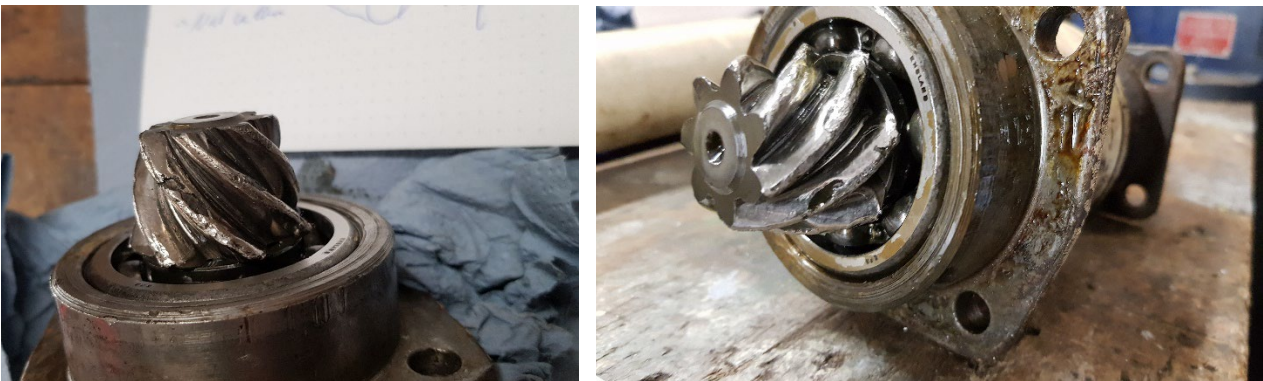
Pinion unit

Teeth 7, printed on the body: 97 (unclear) and below 460;

All teeth are very rough and partially damaged with 1-3 mm roughness;

No wobble when rotated, easy to rotate but slight scratch after half revolution;

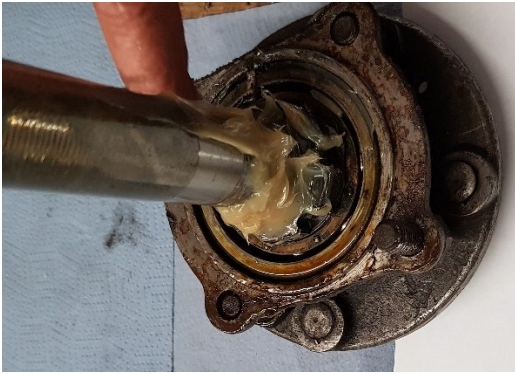
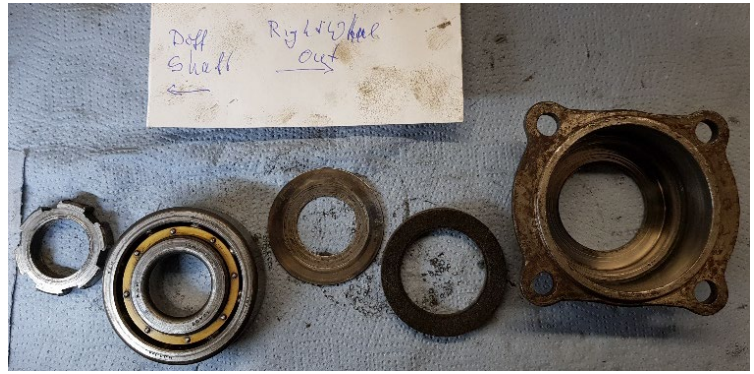
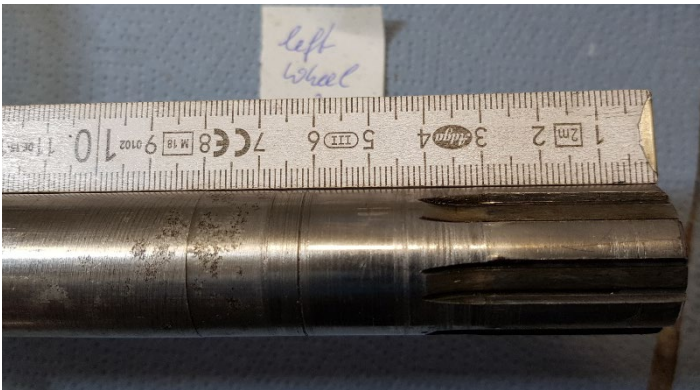
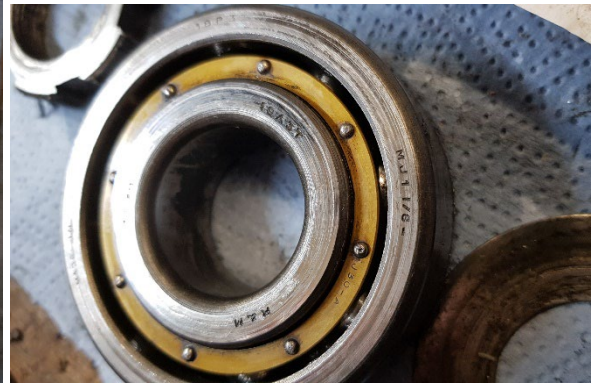
- Right: bearing defect, moveable in axle direction +/- 1-2 mm
- Left: defect radial: shaft at Wheel side D = 28.3 and bearing D = 28.55
Shaft too thin
- Half shaft left, right side identical with
Diameter = 25.25 – 25.35 mm (figure above at 45 mm position and 60 mm) in Diff
Total Length 494 mm, Notches are ok
- Bearings
Outer ring: Diameter = 71.45 mm MJ1 I/8-
Brass ring: J 30 – A
Inner ring: Diameter = 28.62 R&M 31/SM 19AST
Thickness 20.6 mm
- Sealing
Dout = 60.3-60.5, Din = 41.2, w = 7.0 – 8.5 mm
Simmering Doppellippe Din = 41.2, Dout = 60.3, w=9.5,

The old half shaft was too thin in diameter by 0.25 mm so that the bearing was not fix on the half shaft and leads to the wobble of the wheel. We had to increase the half shaft diameter at the bearing position. Therefor we decided to wrap two layers of micrometer foil (0.2 mm thick, stainless steel) which was laser welded on the half shaft. Laser welding set about 200 welding points so that the half shaft diameter increased. Then the needed smaller diameter to fit the ball bearing was produced on a lathe. Laser welding avoids thermal stress and bending of the half shaft!

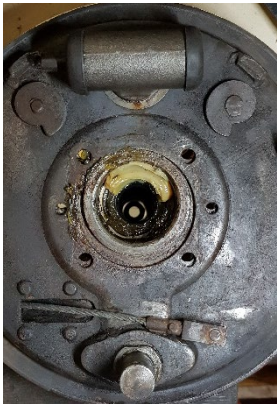
Housing (ring inside)

Din = 44.4 Dout = 71.35

Fits to axle Din = 71.25

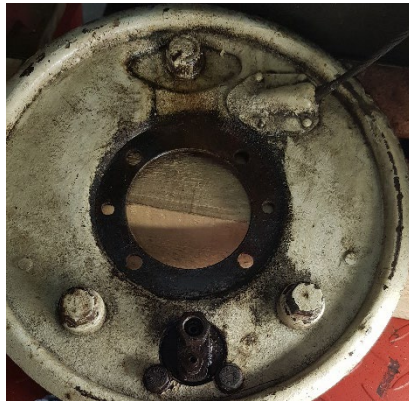
Brake-Plate

Din = 79.6 w = 3.6

Fits to axle Dout = 79.35

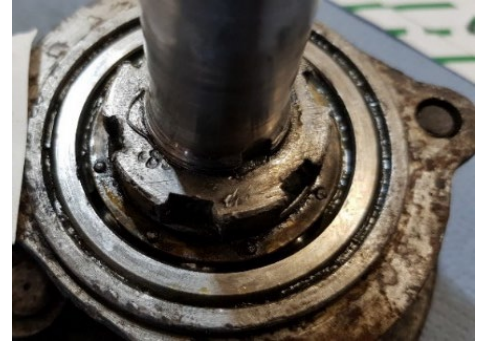
Axle Alignment Ring at Bearing cup

Dout = 79.35 Din = 71.25

=> Brake-Plate is aligned with respect to axle housing via axle alignment ring

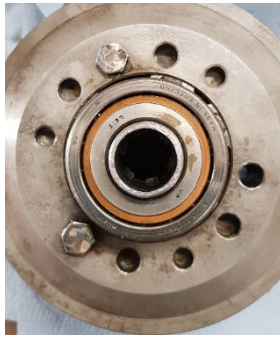
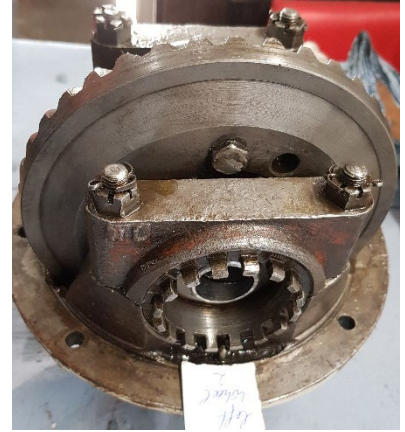
Differential Crown Wheel: 39 teeth Pinion: 7 teeth
Label: Bcwp /6/ 555 / 203 (or first letter R?)

Problem: one of three screws fixing the Crown Wheel was broken (left figure) and the two other were not tight so that the CW was not pressed perfectly to the pinion which must be the reason for scratched teeth on the CW.

When tighten the screw you are producing a tilt of the CW with respect to the axis of rotation. You must monitored and aligned with a dial gauge. Additionally for a perfect alignment of 90 degree between CW and rotation axis I placed micrometer foil (some pieces of 50 μ m and 100 μ m, size some cm, stainless steel) between CW and the planet gear where the CW is screwed on. This compensates the tilt. I stopped alignment procedure when I received a wobbling of the CW by +/- 50 μ m monitored with the dial upon rotation of the CW.

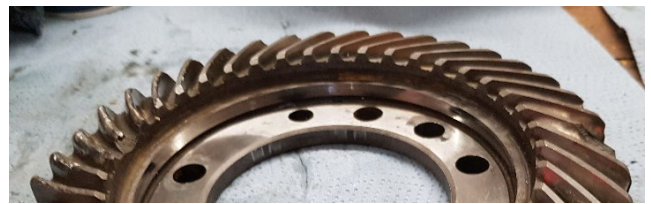
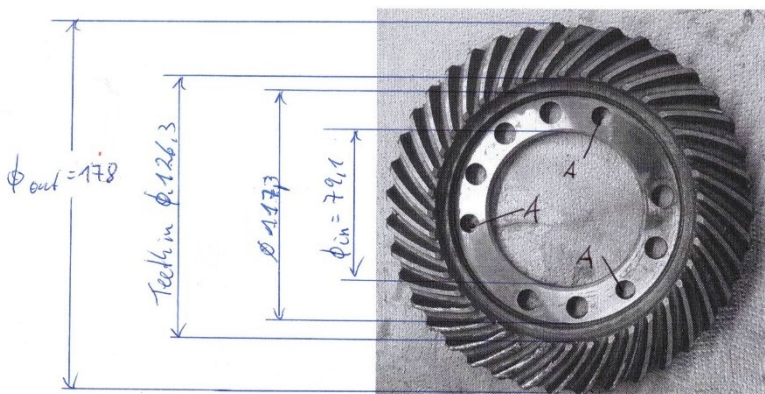
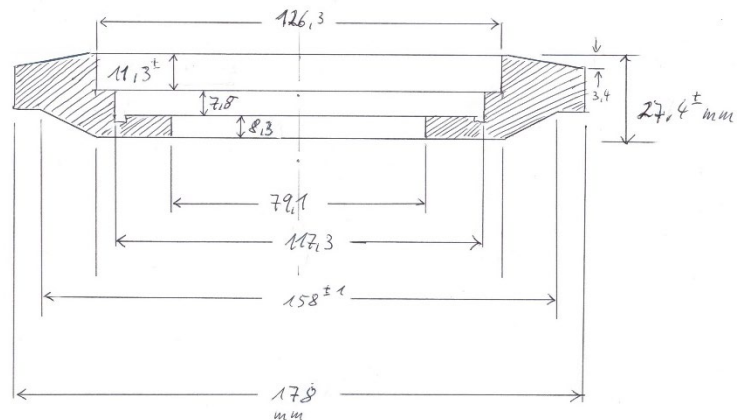
CW

outer & inner Diameter seem to be identical to values for Singer 1934-35 9hp, 34-37 Sports 36-38 Bentam, tabulated in old manuals and workshop books; Figures below with millimeter units

Holes A of diameter D = 9.5 mm (Fig. left), other holes D = 11.2 mm, only 3 holes used for screws

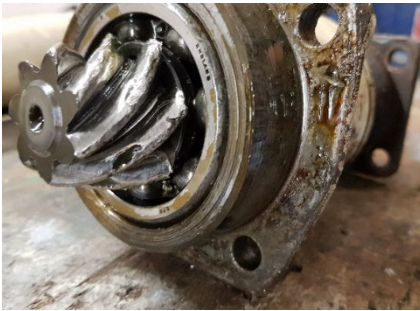
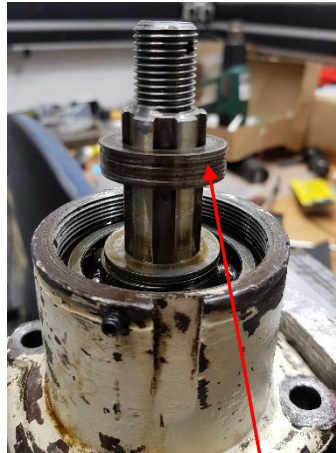
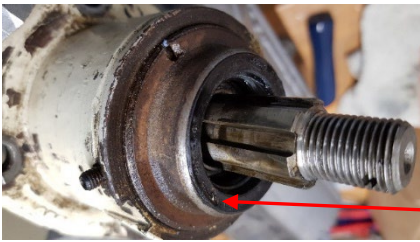
Pinion unit

Teeth 7

No printed on the body: 460

Top Screw, Distance washers
Simmering

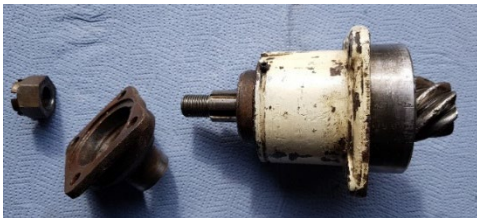
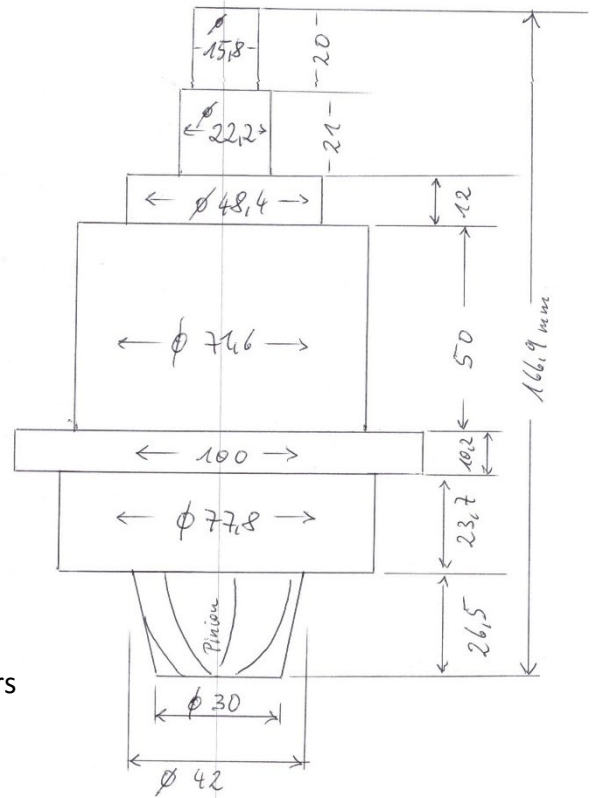
Pinion:

Central hole D = 4,7 mm

The teeth are slightly worn, but in better condition than those of the Crown Wheel
